ANNUAL REPORT FOR 2002

Bethel Church Mitigation Site

Yadkin County

Project No. 6.779004T

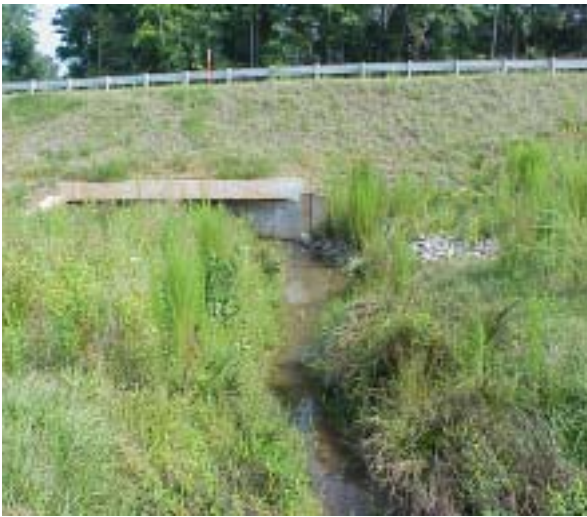
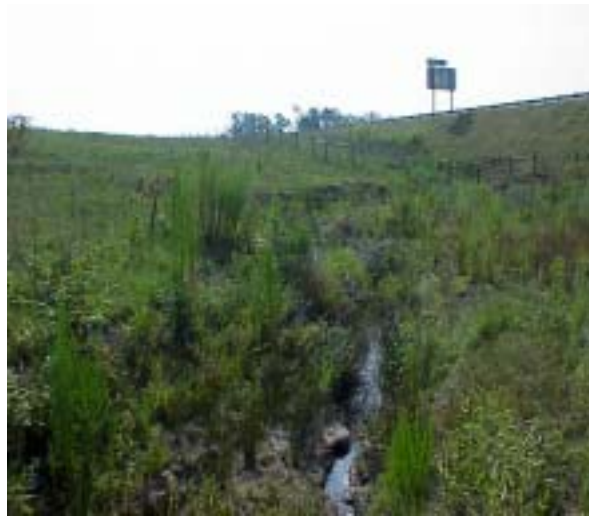
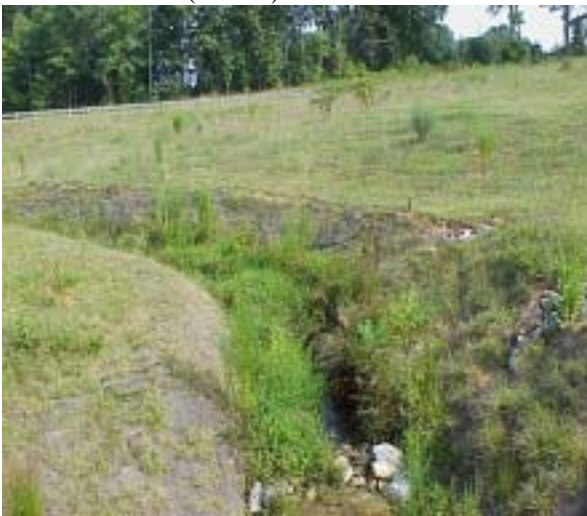
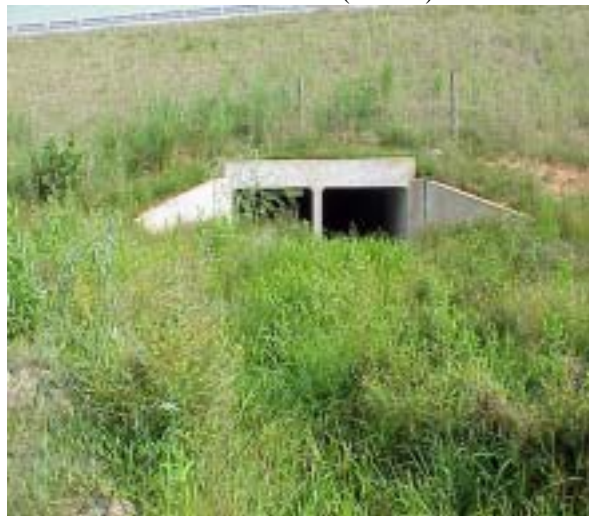
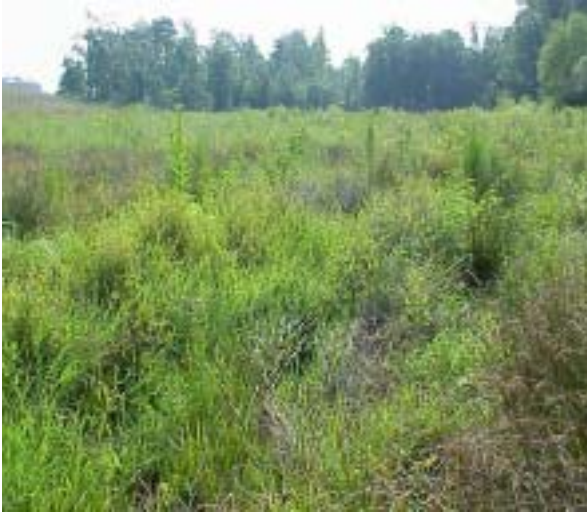
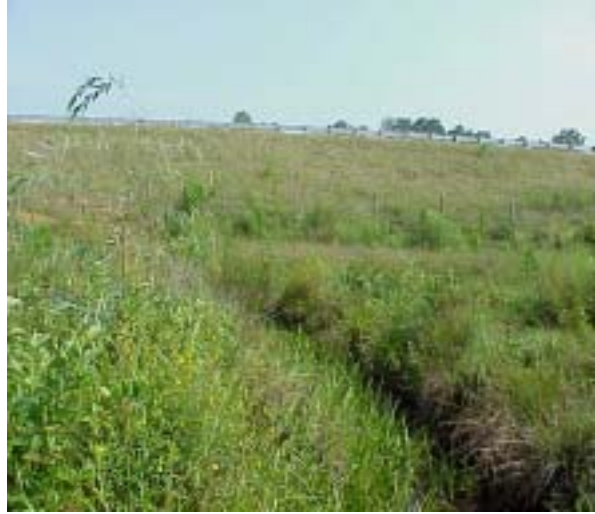
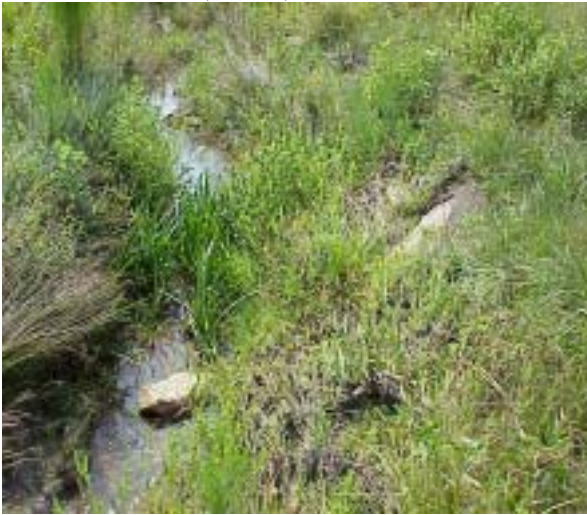
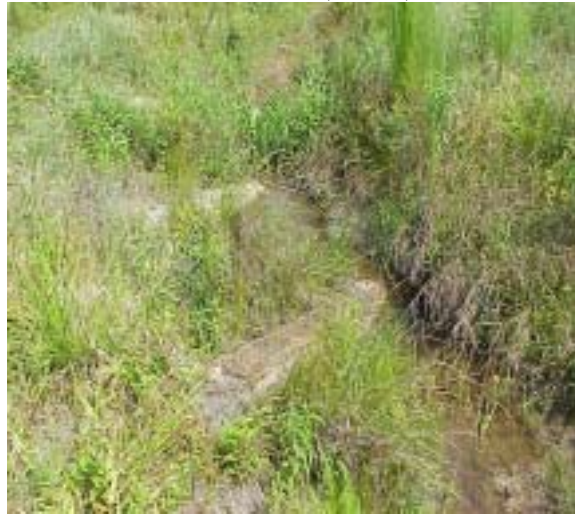
The stream channel was visually monitored during the annual vegetation monitoring of the site. The streambank was mostly vegetated with herbaceous vegetation and stable throughout the length of the channel. Photos 9 through 16 show the conditions of the stream. No remedial actions are necessary. NCDOT will continue vegetation monitoring at the Bethel Church Mitigation Site.
